Quotation

Restoration of Organ Chamber Window with traditional stained glass panel.

St. Thomas Church, Werneth, Oldham (OL8 1SF)

Organ Chamber Window with traditional stained glass panel.

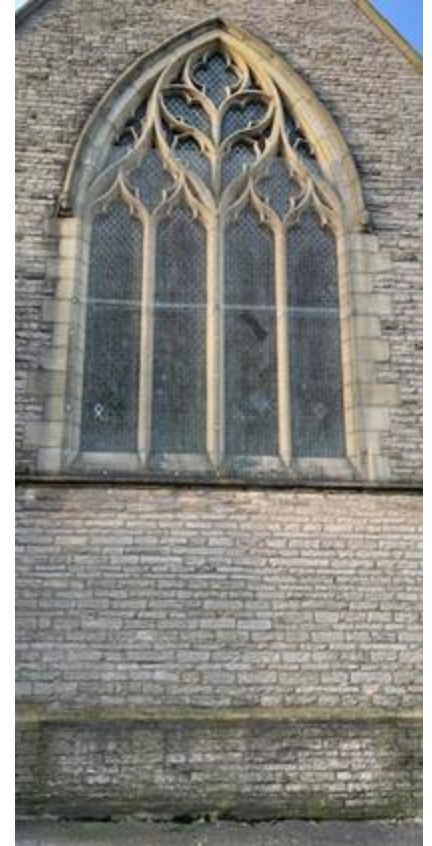
Large lancet stained leaded glass panel size approx. 600mm x 4000mm

Inspection has identified a significant hole affecting stained glass panel.

A section of the leaded panel has failed and has come out of the panel.

The damage is consistent with storm force winds.

- Erect 8 meter scaffolding tower to provide safe access to the window.
- Remove the wire mesh guard
- Remove the damaged stained glass panel from the stone surround and securely board the opening with OSB plywood. Seal to the stone.
- Refit the wire mesh guard

- Carefully dismantle the stained glass panel.
- Replace all broken glass pieces.
- Relead and fully restore the panel to its original condition.

- Erect scaffolding tower for safe access.
- Remove the wire mesh guard
- Reinstall the restored stained glass panel and fit.
- Refit the wire mesh guard
